DOMINION NUCLEAR CONNECTICUT, INC.
MILLSTONE POWER STATION UNITS 2 AND 3
LICENSEE EVENT REPORT 2014-006-00
MILLSTONE POWER STATION DUAL UNIT
REACTOR TRIP ON LOSS OF OFFSITE POWER

LICENSEE EVENT REPORT 2014-006-00
MILLSTONE POWER STATION DUAL UNIT
REACTOR TRIP ON LOSS OF OFFSITE POWER

Millstone Power Station Dual Unit Reactor Trip on Loss of Offsite Power

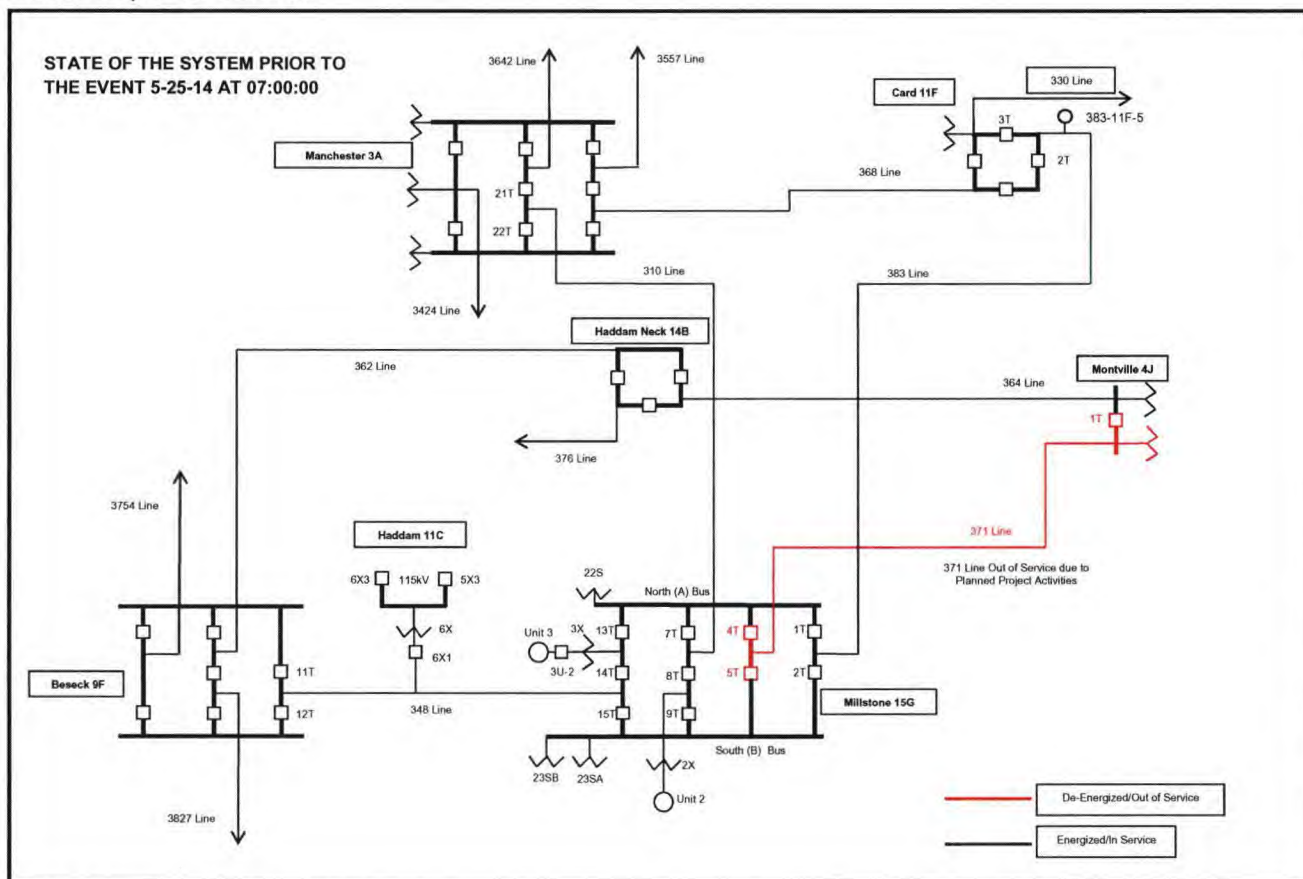
The switchyard, which is configured in a breaker and a half arrangement, buses together four 345 kV transmission line circuits, two generator circuits and two station service circuits.

The four transmission line circuits terminated at the switchyard are:

- TO Millstone to Beseck Line Number 348
- TO Millstone to Card Line Number 383
- TO Millstone to Montville Line Number 371
- TO Millstone to Manchester Line Number 310

These circuits connect the station to the 345 kV system transmission grid and constitute the MPS offsite AC power source.
